Richard B. Russell Dam and Lake

Final Foundation Report Volume 2 of 2

US Army Corps
of Engineers
Savannah District

RICHARD B. RUSSELL PROJECT
SAVANNAH RIVER, GEORGIA AND SOUTH CAROLINA
FINAL FOUNDATION REPORT
CONCRETE DAM, EMBANKMENTS, AND POWERHOUSE

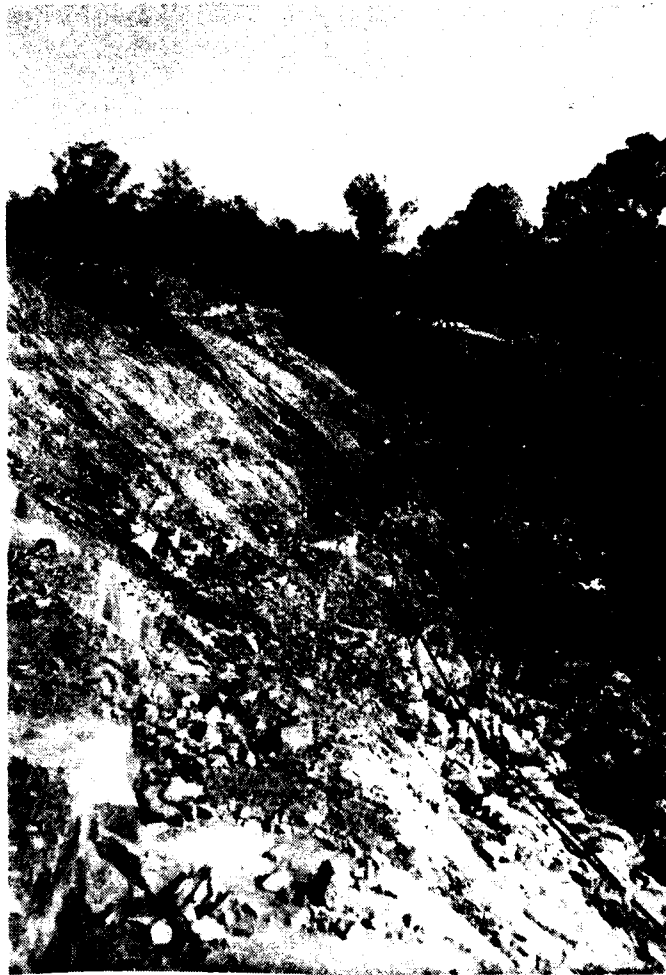
Photo 188 - Drilling grout holes on the A-Line, South Carolina embankment.
